APOLLO PROGRAM SUMMARY REPORT

National Aeronautics and Space Administration
LYNDON B. JOHNSON SPACE CENTER
Houston, Texas

April 1975

JSC-09423

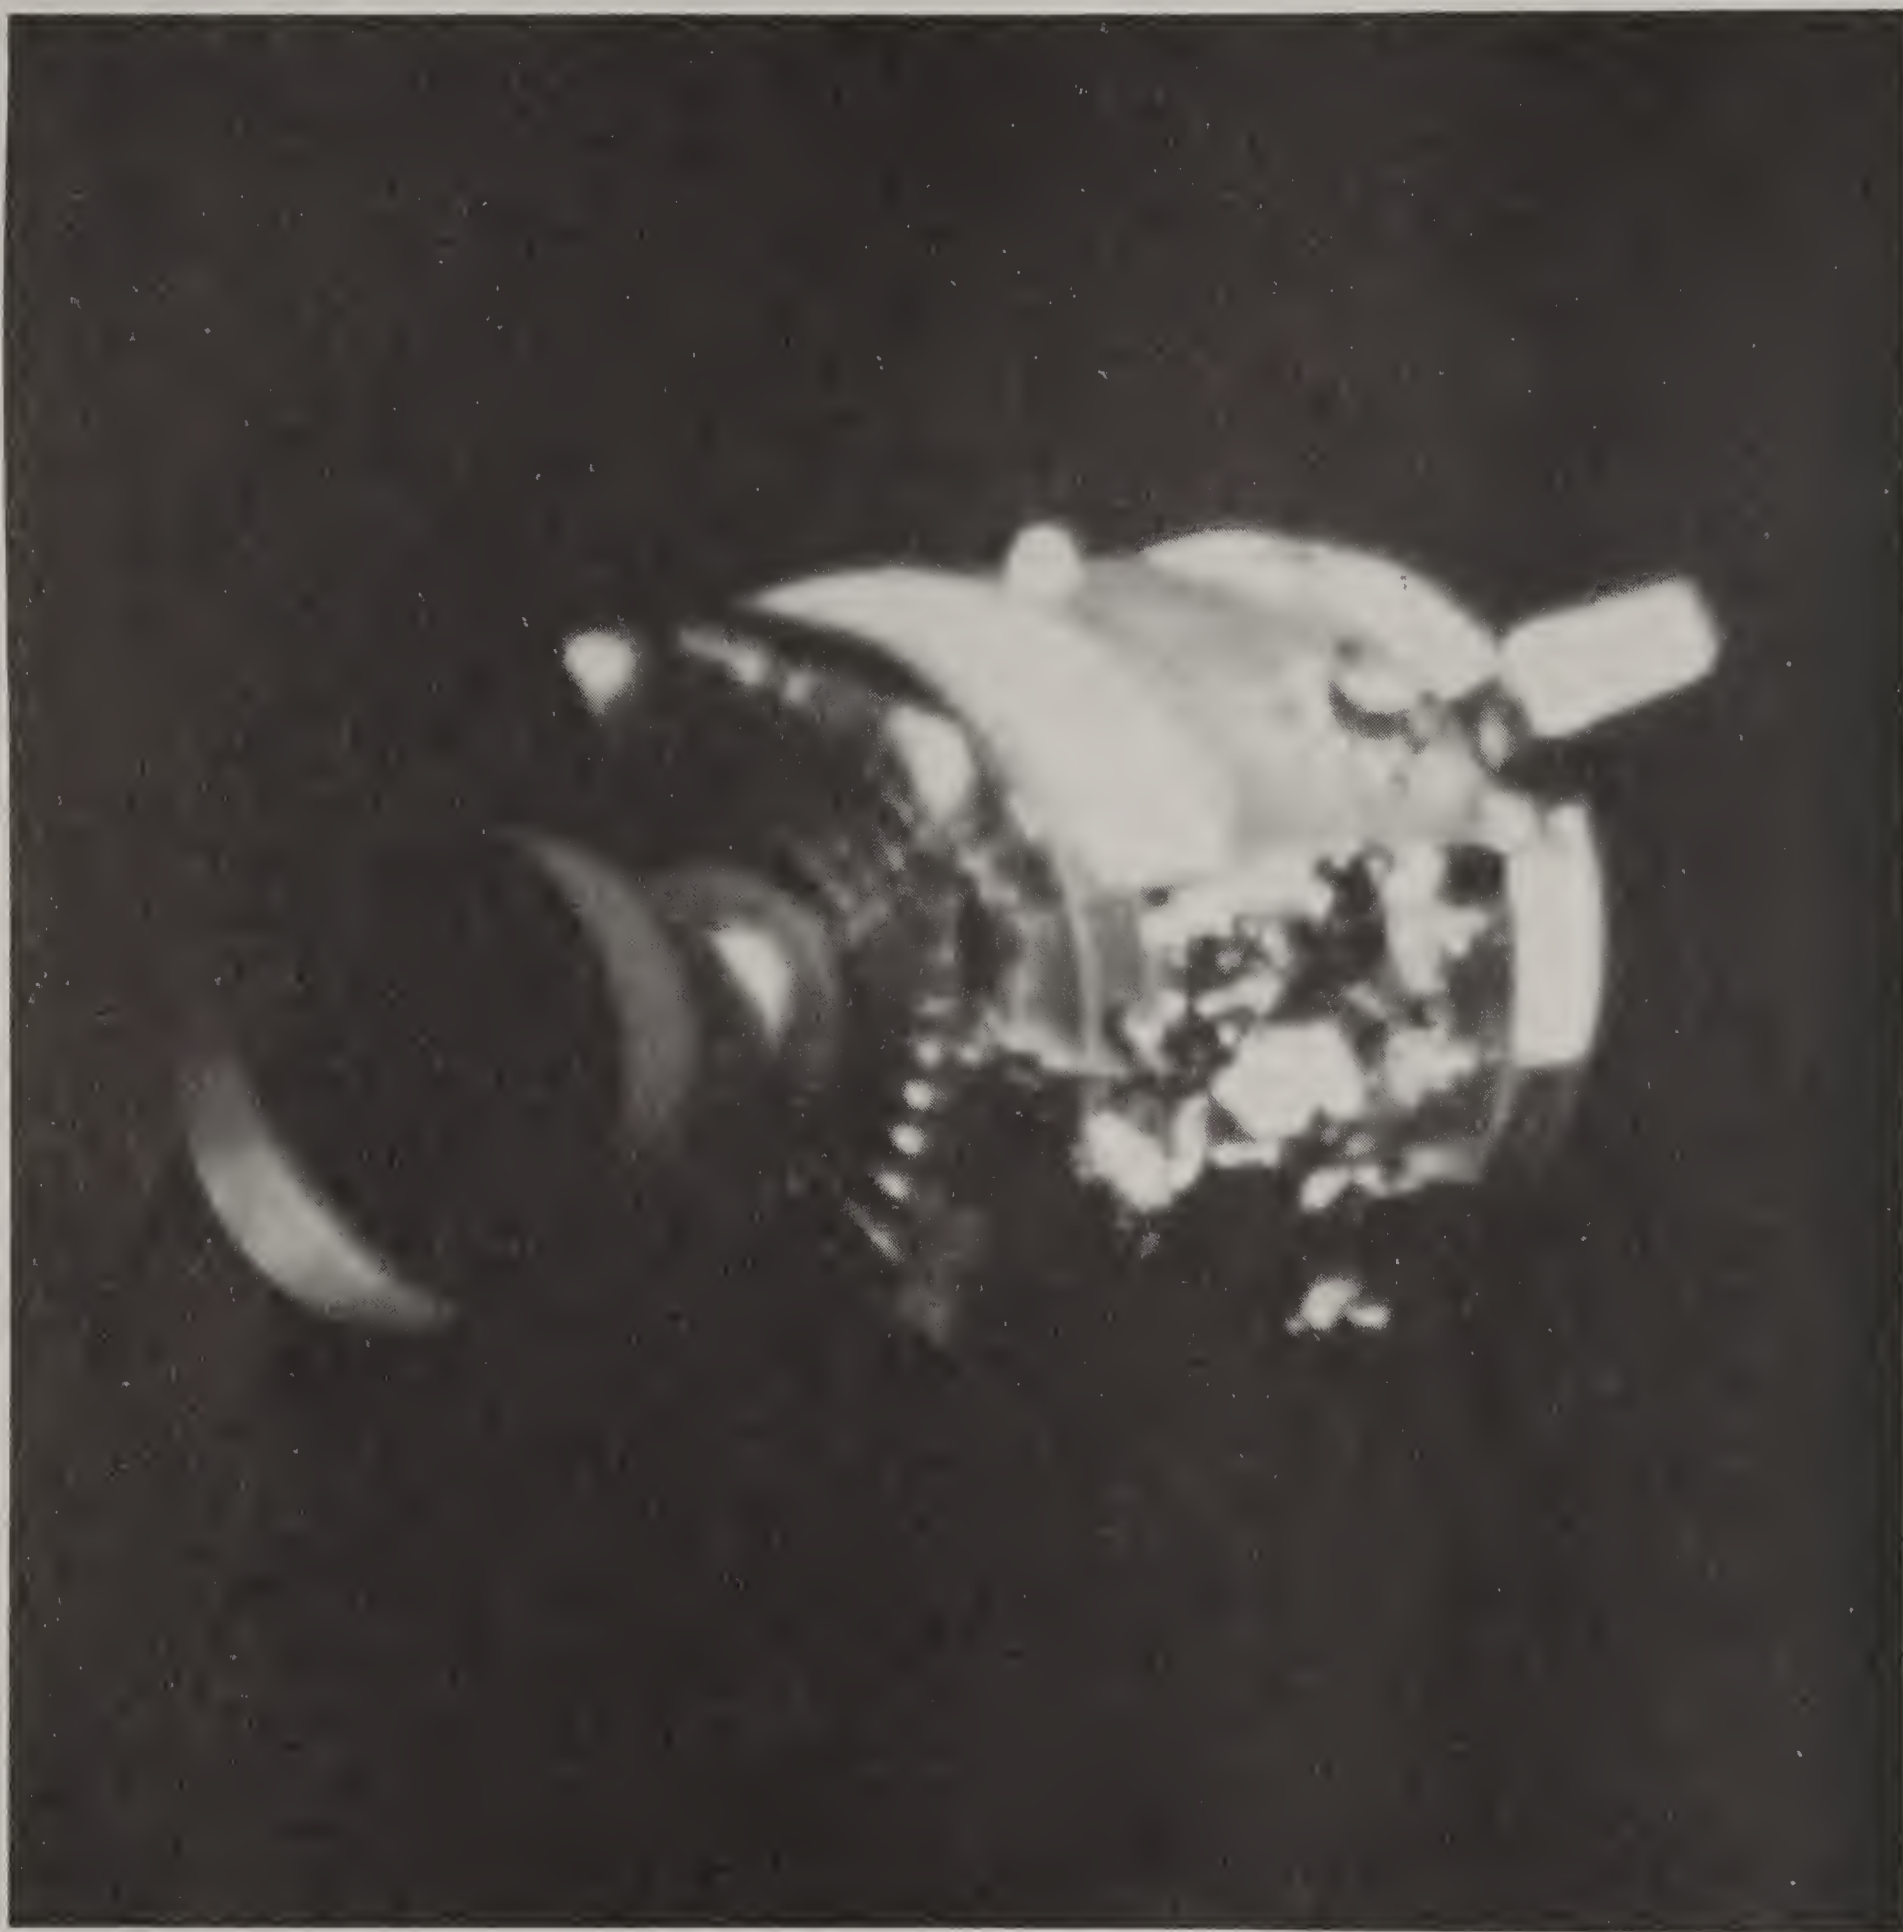
Figure 2-17.- Photograph of damaged service module taken during Apollo 13 mission.

An investigation into the cause of the Apollo 13 cryogenic oxygen tank failure led to three significant changes in the command and service module cryogenic oxygen storage and electrical power systems. The internal construction of the oxygen tanks was modified, a third oxygen tank was added, and an auxiliary battery was installed. These changes were also incorporated into all subsequent spacecraft.

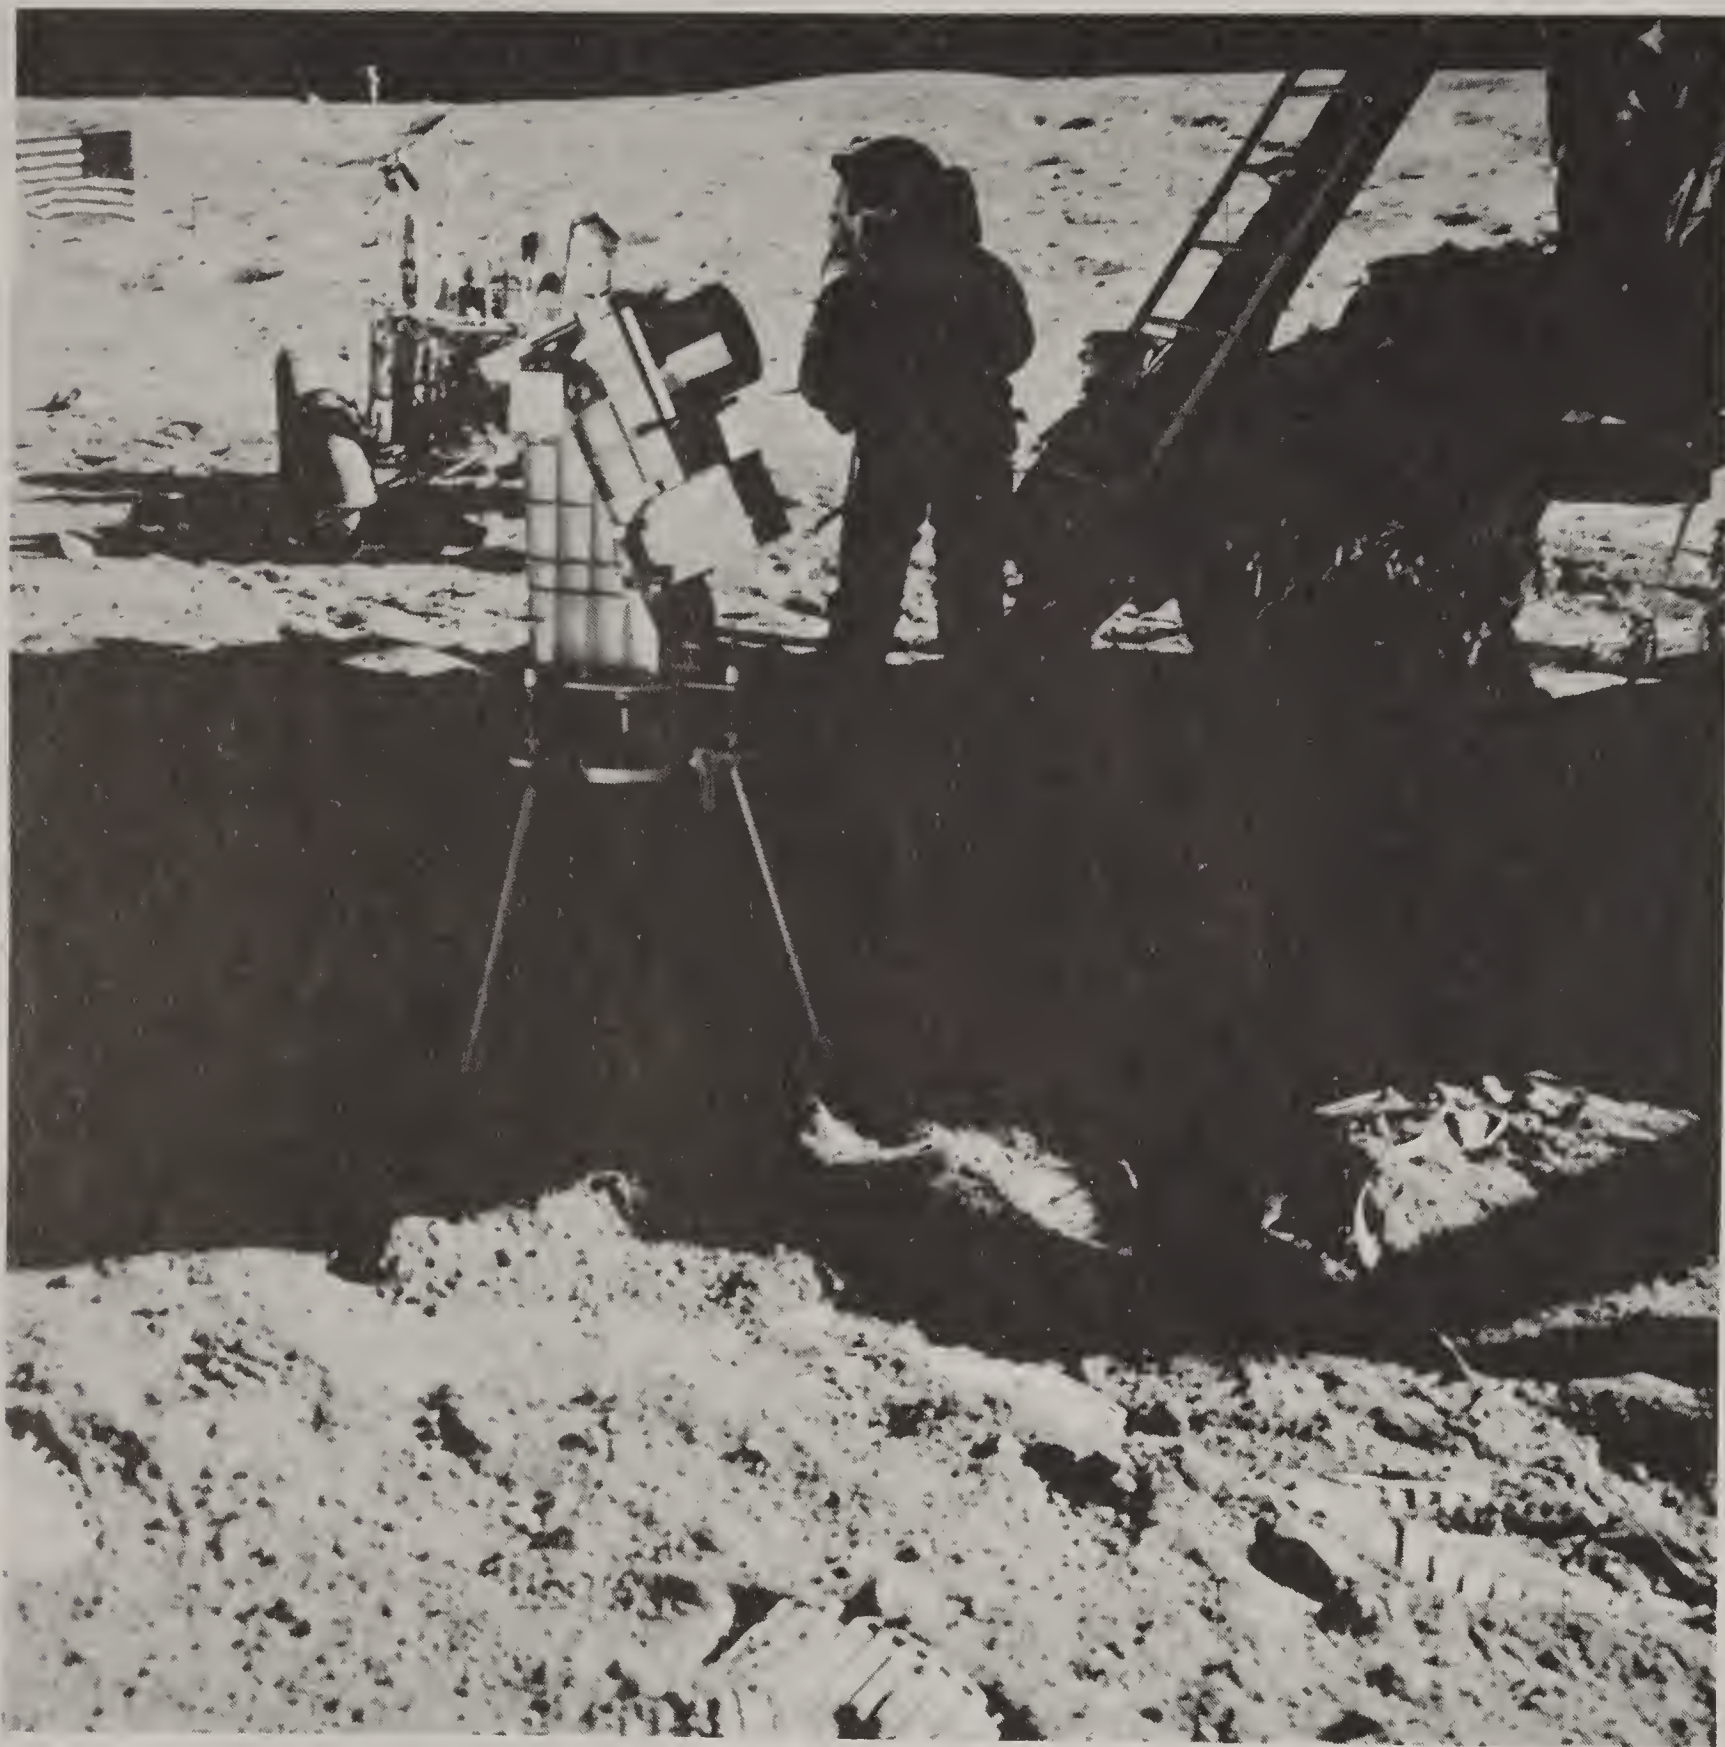
A far-ultraviolet camera/spectrograph experiment (fig. 3-26) was operated on the lunar surface during the Apollo 16 mission. Among the data obtained were images and spectra of the terrestrial atmosphere and geocorona in the wavelength range below 1600 angstroms. These data gave the spatial distributions and relative intensities of emissions due to atomic hydrogen, atomic oxygen, molecular nitrogen, and other elements - some observed spectrographically for the first time. A more detailed account of the findings of this experiment can be found in reference 3-37.

Figure 3-26.- Far ultraviolet camera/spectrograph experiment.
